Evaluating Trout Stream Restoration Benefits: A Case Study at Pine Creek, Wisconsin

Kent Johnson

Aquatic Biologist, Kiap-TU-Wish Chapter, Trout Unlimited, Hudson, WI

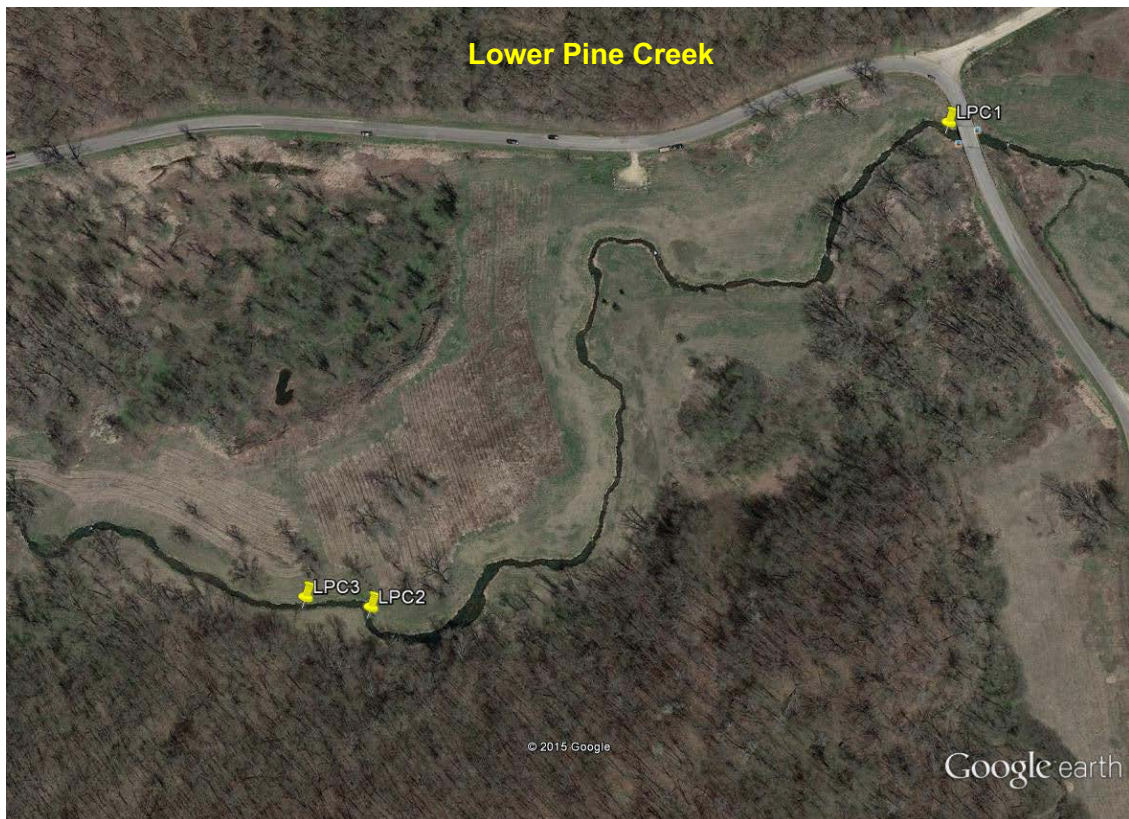
Figure 6. Pine Creek macroinvertebrate monitoring sites

Pre- and post-restoration monitoring of the Pine Creek macroinvertebrate community was conducted at 8 locations within the project restoration area (Figure 6), using the single-habitat kick-sampling method described by Hilsenhoff (1987 and 1988) and Plafkin, et al. (1989). Pre-restoration macroinvertebrate samples were obtained in June 2009, while post-restoration macroinvertebrate samples were obtained in June 2013. With the exception of oligochaetes, all macroinvertebrates in these samples were identified to the genus level. The taxonomic analysis was conducted by Dr. Leonard Ferrington, Professor in the Department of Entomology at the University of Minnesota. Multiple metrics were used to compare the pre- and post-restoration macroinvertebrate communities (Barbour, et al. 1999). These metrics included richness measures (total number of taxa, number of EPT taxa, number of chironomidae taxa), composition measures (% EPT taxa, % chironomidae taxa), and tolerance/intolerance measures (% dominant taxon and the Hilsenhoff Biotic Index (HBI) (Hilsenhoff (1987 and 1988)). Although no project objective was established for macroinvertebrates, monitoring was helpful to determine whether restoration benefits were evident for this critical component of the coldwater community.

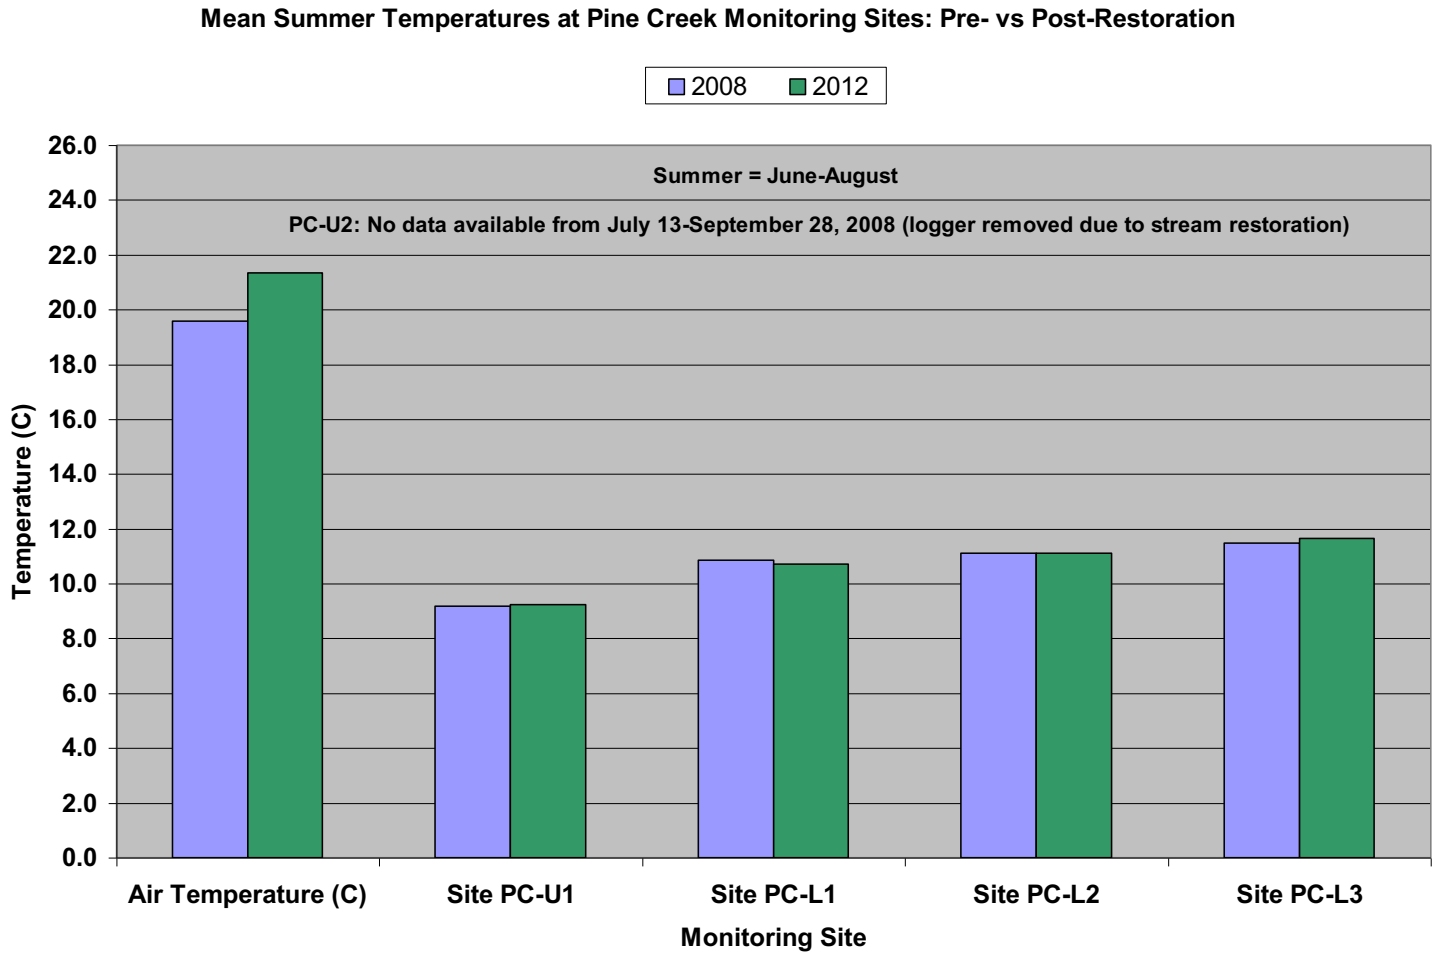
Figure 7. Mean summer temperatures at Pine Creek monitoring sites: Pre- restoration vs. post-restoration

Pine Creek Water Temperatures at All Sites

Pre- and post-restoration mean summer (June-August) temperatures at Pine Creek monitoring sites were nearly identical (Figure 7), ranging from 9.2° C at PC-U1 to 11.6° C at PC-L3. According to Cunningham et al. (2014), the optimum temperature range for brook trout is 13-16° C. Combining all temperature data for the monitoring sites in the restoration project reach, 99.6% of pre- and post-restoration summer temperatures were less than 16° C (top of optimum temperature range for brook trout). Both pre- and post-restoration temperature data indicate a strong groundwater influence and an exceptional temperature regime for brook trout in Pine Creek.

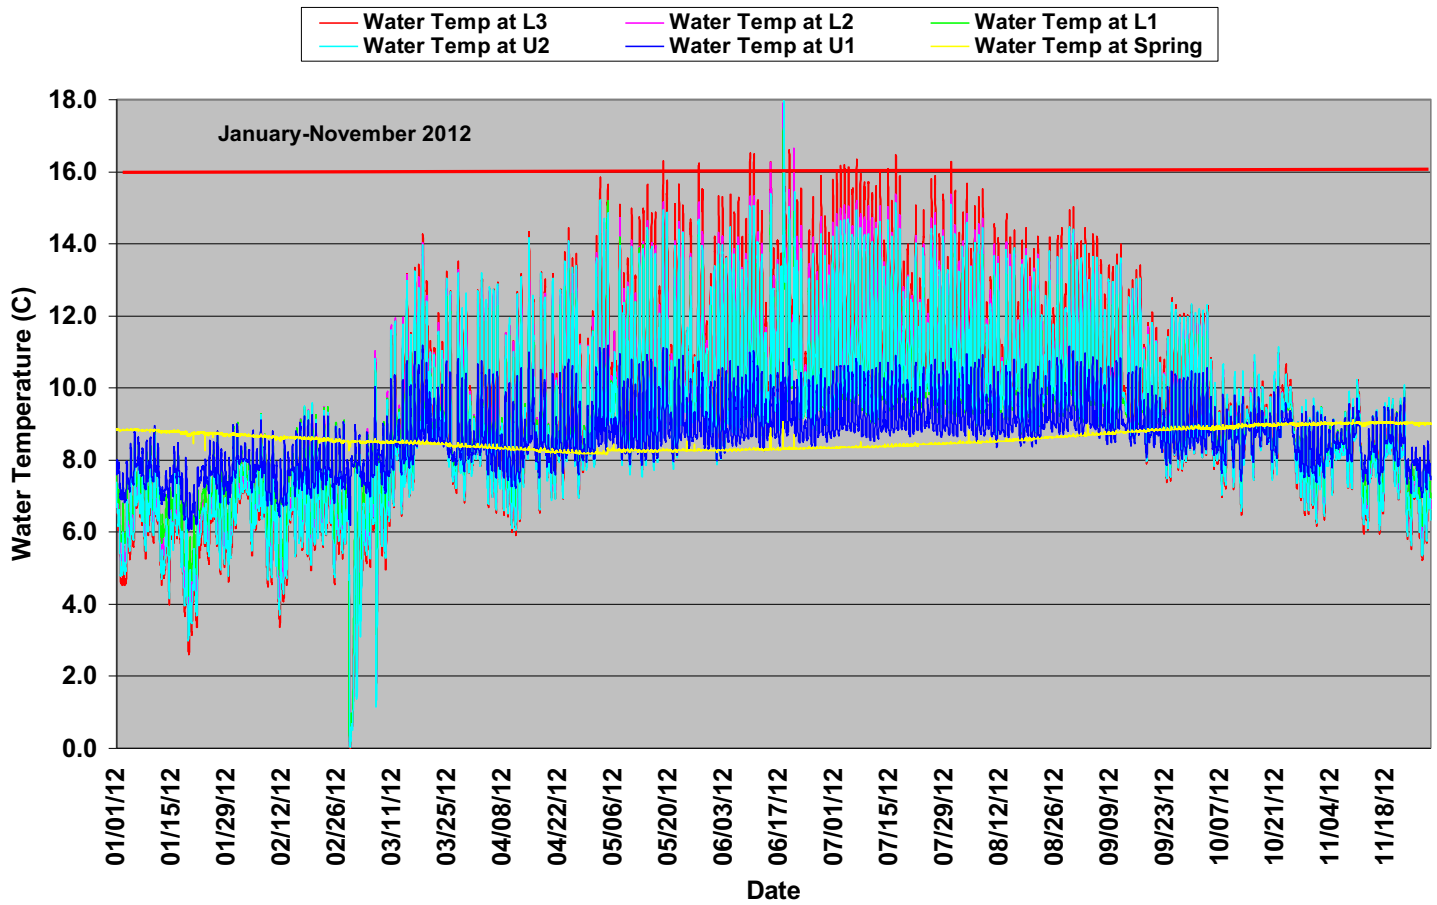
Figure 8. Reach-scale influence of air temperature on Pine Creek water temperature

In spite of a strong groundwater influence and an exceptional temperature regime for brook trout, reach-scale impacts of air temperature on water temperature are still very significant in Pine Creek, as shown in Figure 8. Post-restoration (2012) temperatures increased markedly from upstream (PC-U1) to downstream (PC-L3) through the 2,665-meter (1.7-mile) restoration reach, as the stream moved away from headwater groundwater sources and became increasingly susceptible to air temperature. The pre- and post-restoration influence of air temperature on stream temperature is also noted in the downstream increase in mean summer temperatures through the restoration reach (Figure 7).

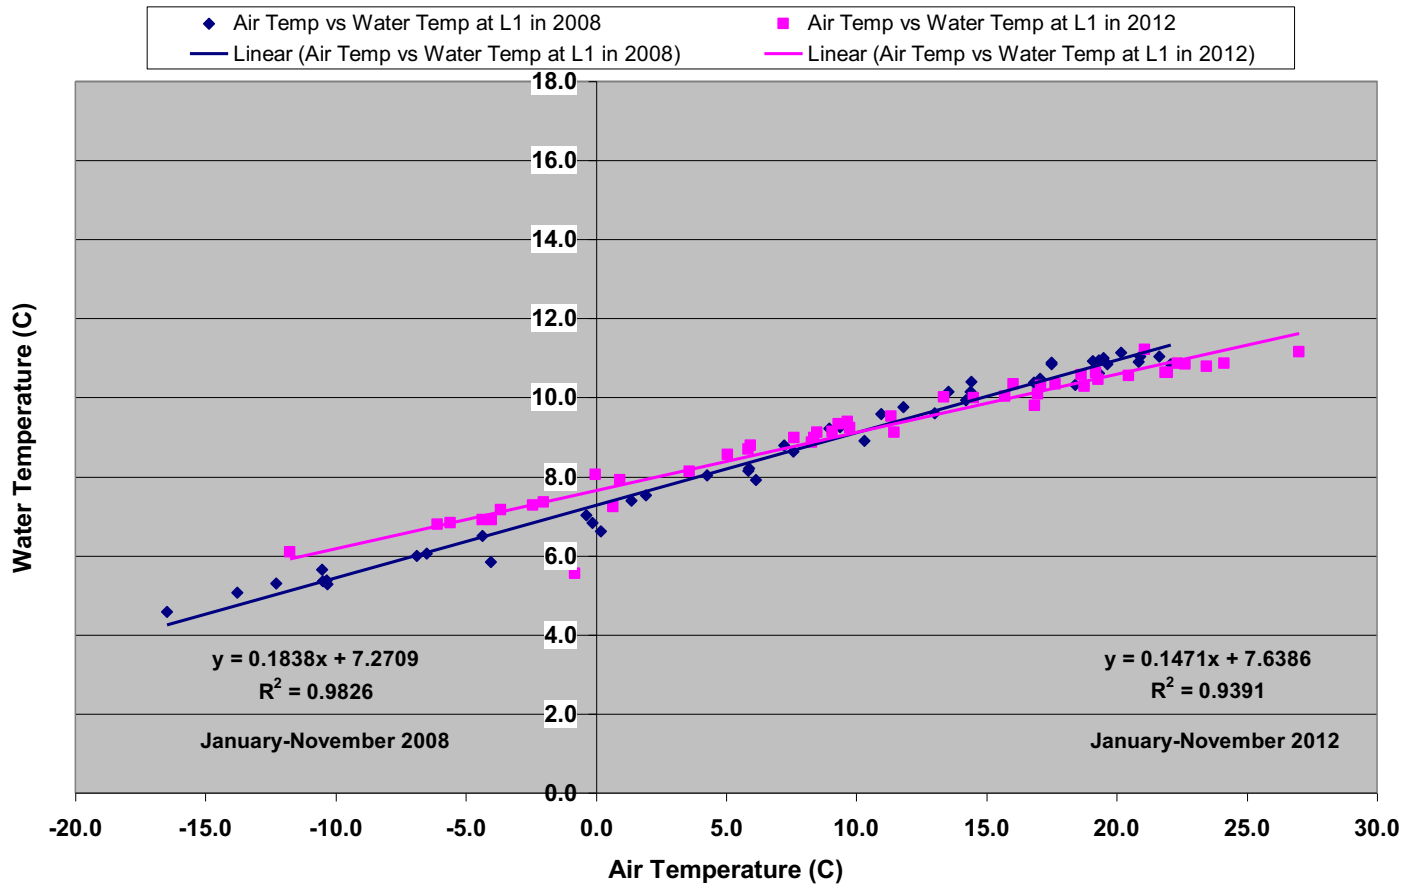
**Pine Creek Air Temperature vs Water Temperature at L1:
Pre-Restoration vs Post-Restoration**

Figure 10. Pine Creek air temperature vs. water temperature at PC-L1: Pre-restoration vs. post-restoration

monitoring locations. An example of the application of Krider’s model to pre- and post-restoration stream temperatures at PC-L1 is provided in Figure 10. A post-restoration improvement in stream temperature at this location is evident by the reduced slope of the post-restoration regression line (0.1471), compared to the slope of the pre-restoration regression line (0.1838), indicating a reduced susceptibility of stream temperature to air temperature post-restoration. At upstream locations in the restoration reach (PC-U1 and PC-U2), those closest to groundwater sources and hydrologically-dominated, no post-restoration temperature improvements were noted. However, post-restoration temperature improvements were evident at all downstream locations in the restoration reach (PC-L1, PC-L2, and PC-L3), those more distant from groundwater sources and more subject to air temperature influence. Due to reach-scale impacts of air temperature (Figures 7 and 8), these temperature improvements became less apparent at PC-L2 and PC-L3. Although subtle, this shift in the air-water temperature relationship through the lower restoration reach provides a buffer against future climate change impacts on Pine Creek.

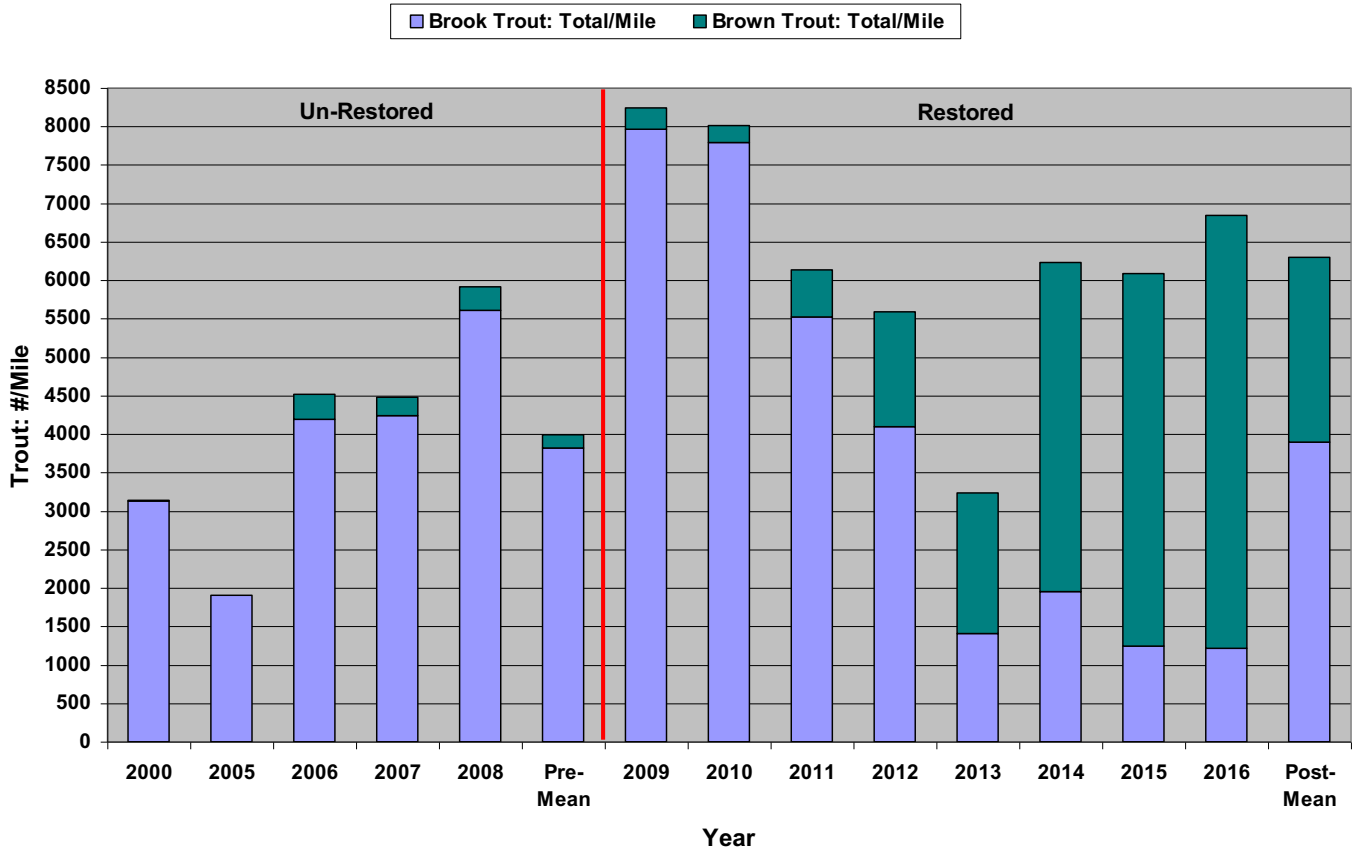
Pine Creek (2A) Pre vs Post Restoration Trout: Total/Mile

Figure 14. Pre- and post-restoration abundance of brook trout and brown trout in Pine Creek
