**Wild Trout Symposium XII  
West Yellowstone, Montana  
September 26-29, 2017**

# **Evaluating Trout Stream Restoration Benefits: A Case Study at Pine Creek, Wisconsin**

**Kent Johnson, Kiap-TU-Wish Chapter, Trout Unlimited**

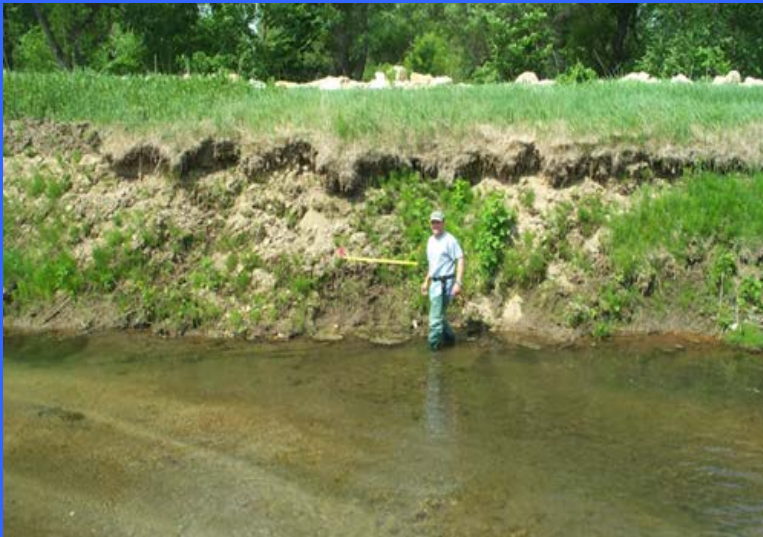
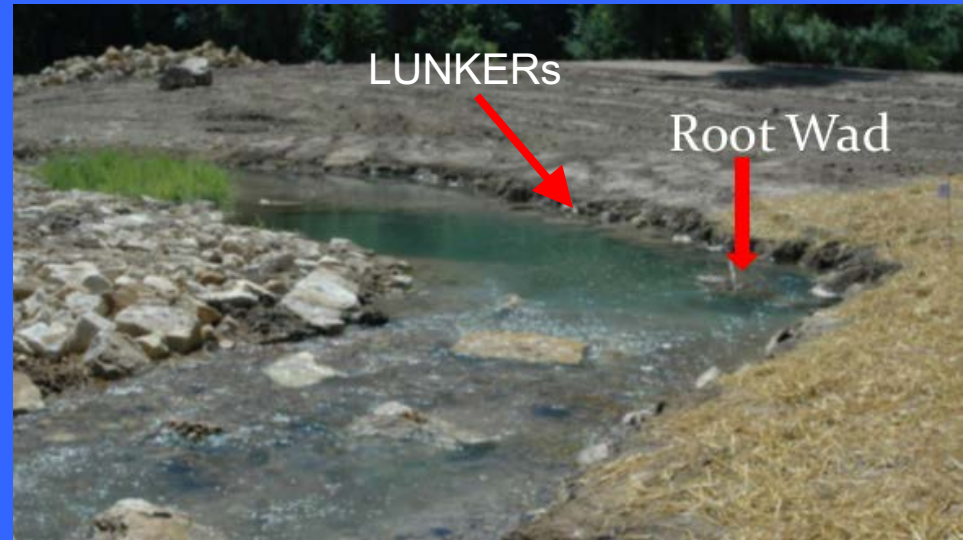
# WDNR Stream Restoration Methods

- Grade stream banks at a 3:1 slope, for floodplain access
- Stabilize and re-vegetate stream banks, for erosion reduction
- Narrow and deepen the stream channel
- Increase flow velocity, for groundwater conveyance
- Install LUNKER structures, for trout cover and flood refuge
- Install boulder clusters and root wads, for mid-stream trout cover
- Excavate plunge pools for deep water and over-wintering habitat

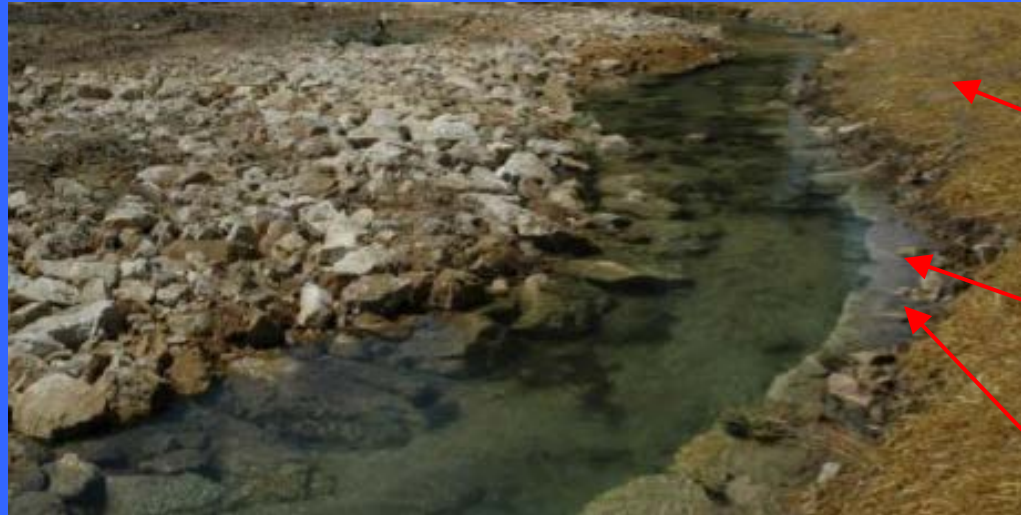
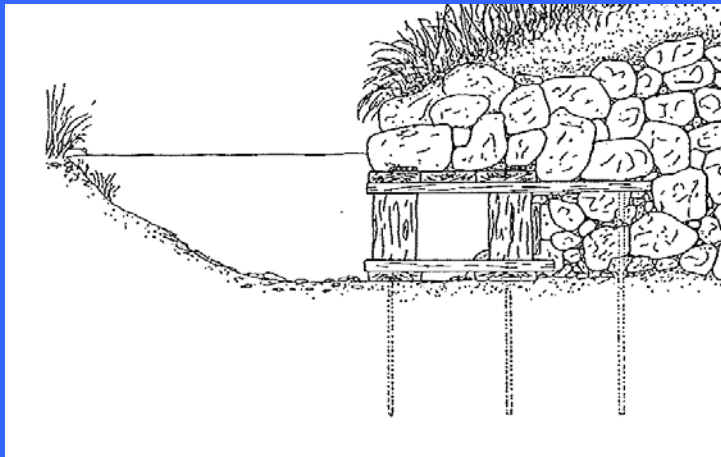
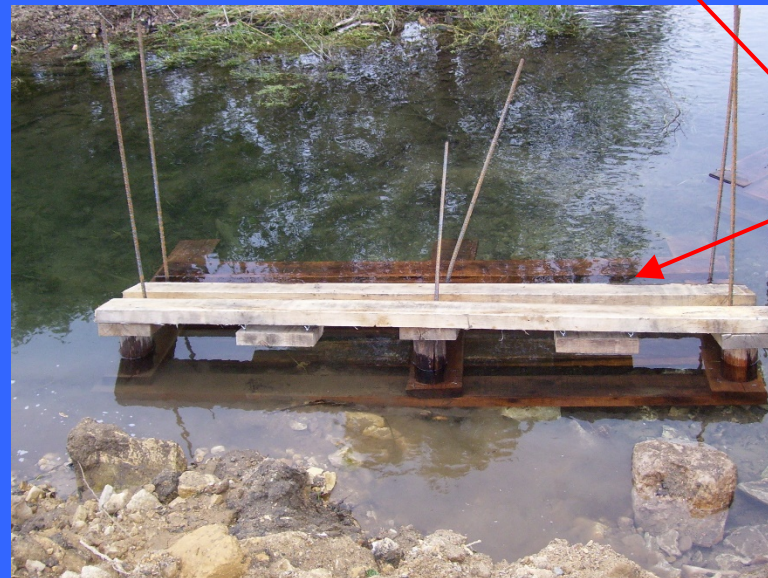
# Lower Pine Creek Restoration Work (2007)

## LUNKER\* Structures

Stream bank  
seeded and  
mulched

Rip-rap  
placed

LUNKER  
Structures

\*Little Underwater Neighborhood Keepers Encompassing Rheotactic Salmonids (Vetrano 1988)

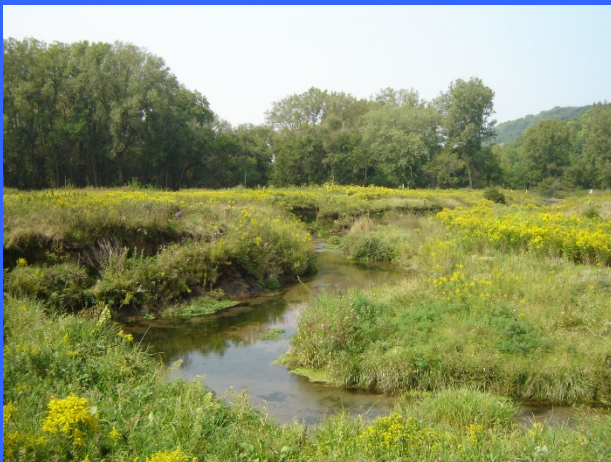
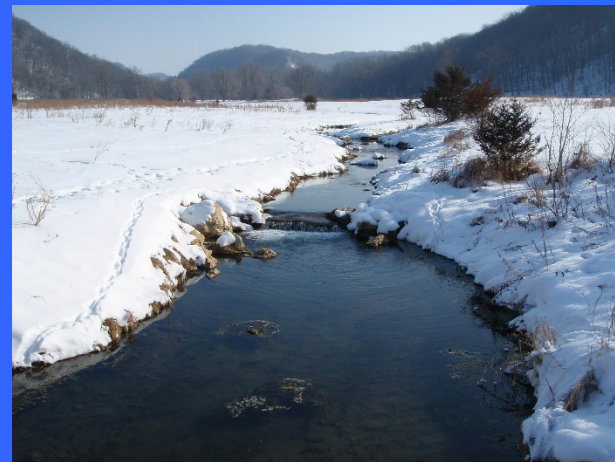
# Pine Creek Restoration Project: 2007-2011 Project Summary

Total Stream Length Restored: 11,167 feet (2.11 miles)

- Upper Pine Creek: 4,365 feet (0.83 mile)
- Lower Pine Creek: 4,378 feet (0.83 mile)
- North Spring Tributary: 914 feet (0.17 mile)
- South Spring Tributary: 1,380 feet (0.26 mile)
- North Branch Tributary: 130 feet (0.02 mile)

Total Restoration Cost: \$270,273 (\$24/foot)

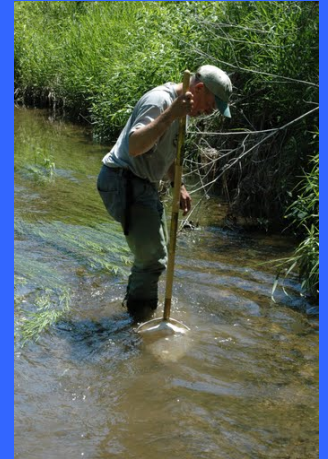
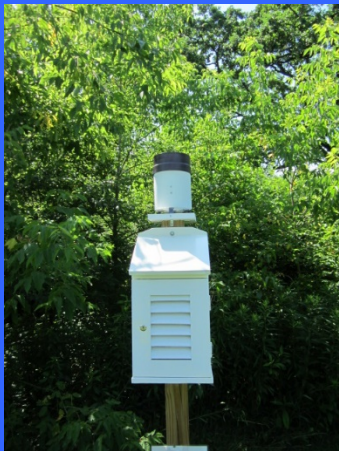
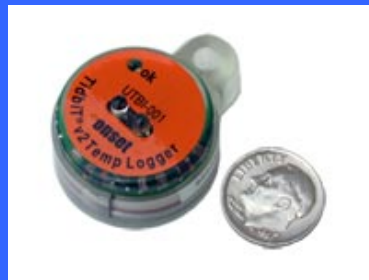
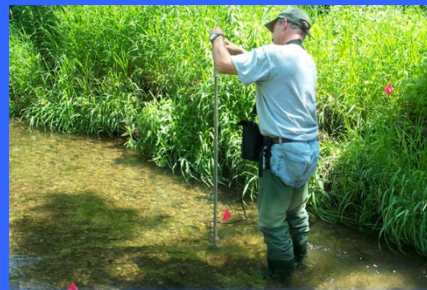
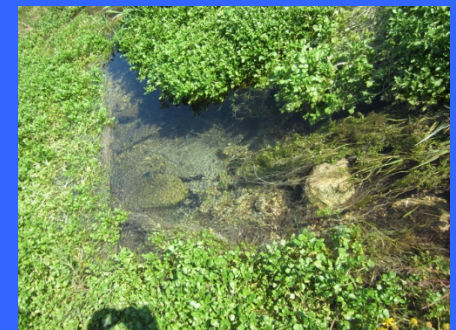
# Pine Creek Monitoring Summary

## Pre- and Post-Restoration Monitoring:

- Climate conditions (on-site weather station)
- Spring and stream temperature (6 sites)
- Habitat assessment (18 sites)
- Macrophyte presence (18 sites)
- Macroinvertebrate communities (8 sites)
- Trout surveys (2 sites)

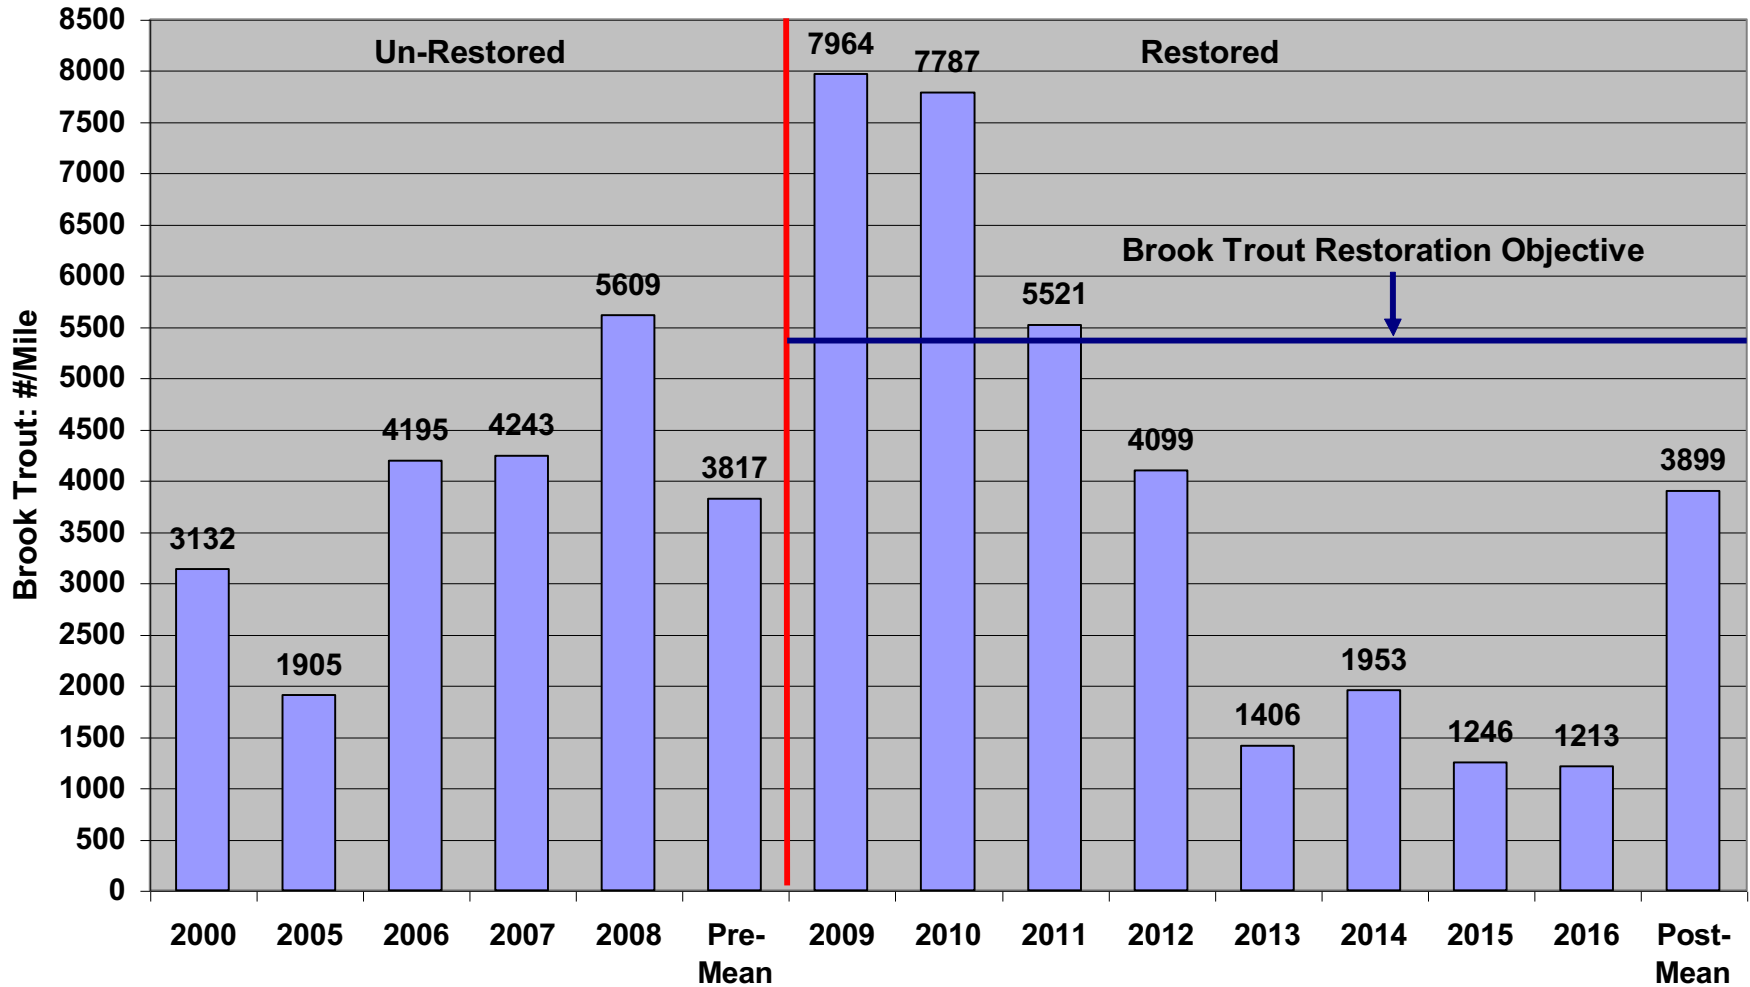
## Pine Creek (2A) Pre- vs Post-Restoration Brook Trout: Total/Mile

# Project Objective: Increase Numbers of Brook Trout by 40-50%

Brook Trout: Total/Mile

~70% decrease in Brook Trout abundance by 2016

Project Objective 5 targeted a 40-50% increase in Brook Trout numbers

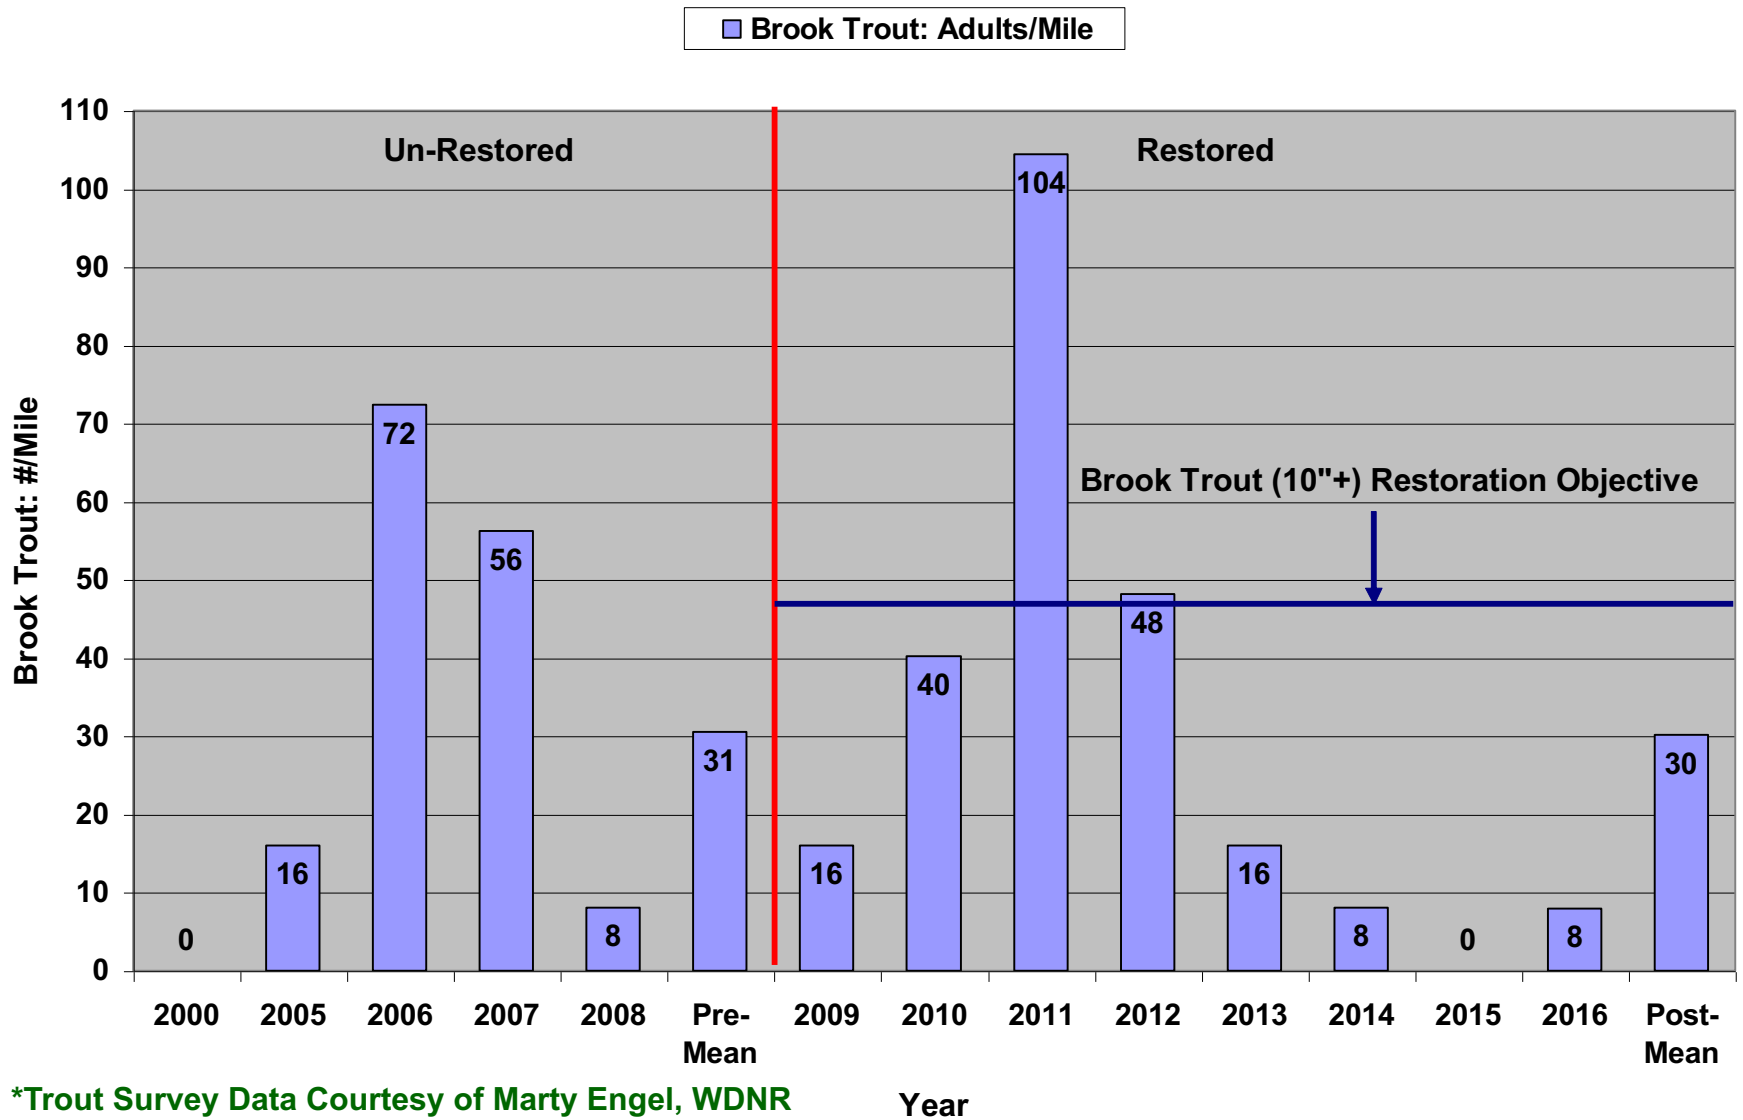
## Pine Creek (2A) Pre vs Post Restoration Brook Trout: Adults (10"+)/Mile

# Project Objective: Increase Numbers of Brook Trout 10"+ by 50-100%

~75% decrease in abundance of 10-inch+ Brook Trout by 2016

Project Objective 6 targeted a 50-100% increase in 10-inch+ Brook Trout numbers

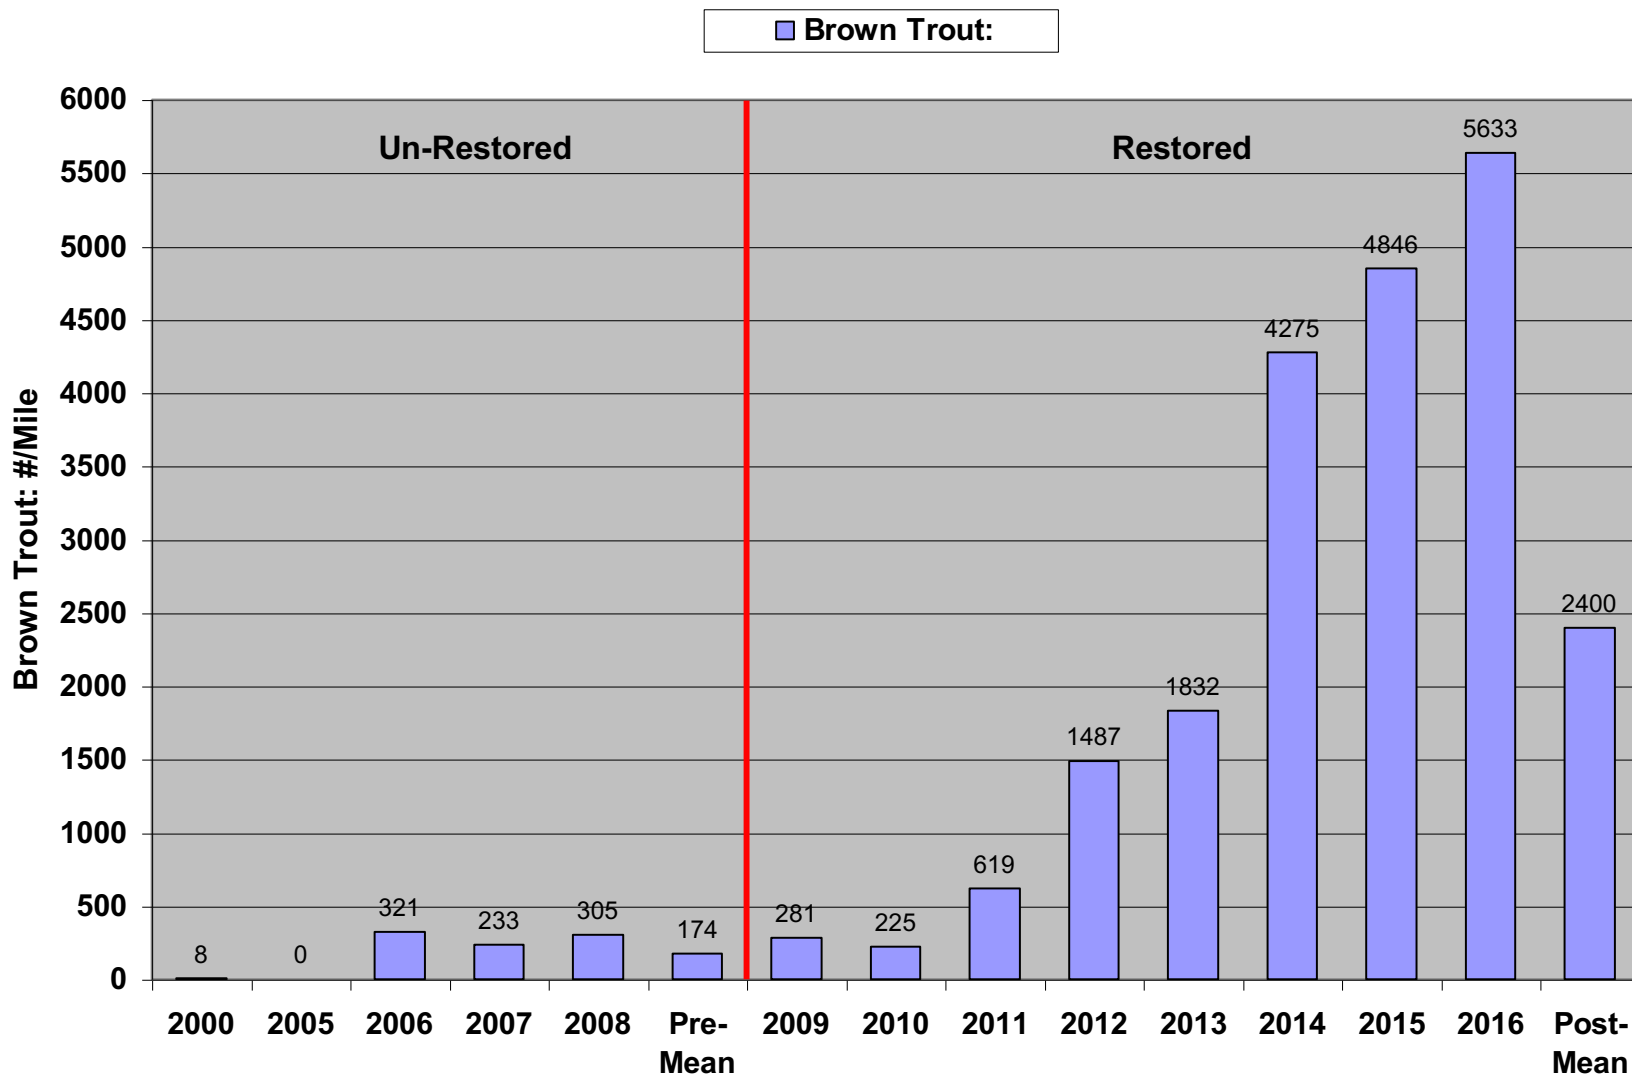
Pine Creek (2A) Pre vs Post Restoration Brown Trout: Total/Mile

# Brown Trout Abundance in Pine Creek: 2000-2016

>3,000% increase in Brown Trout abundance by 2016

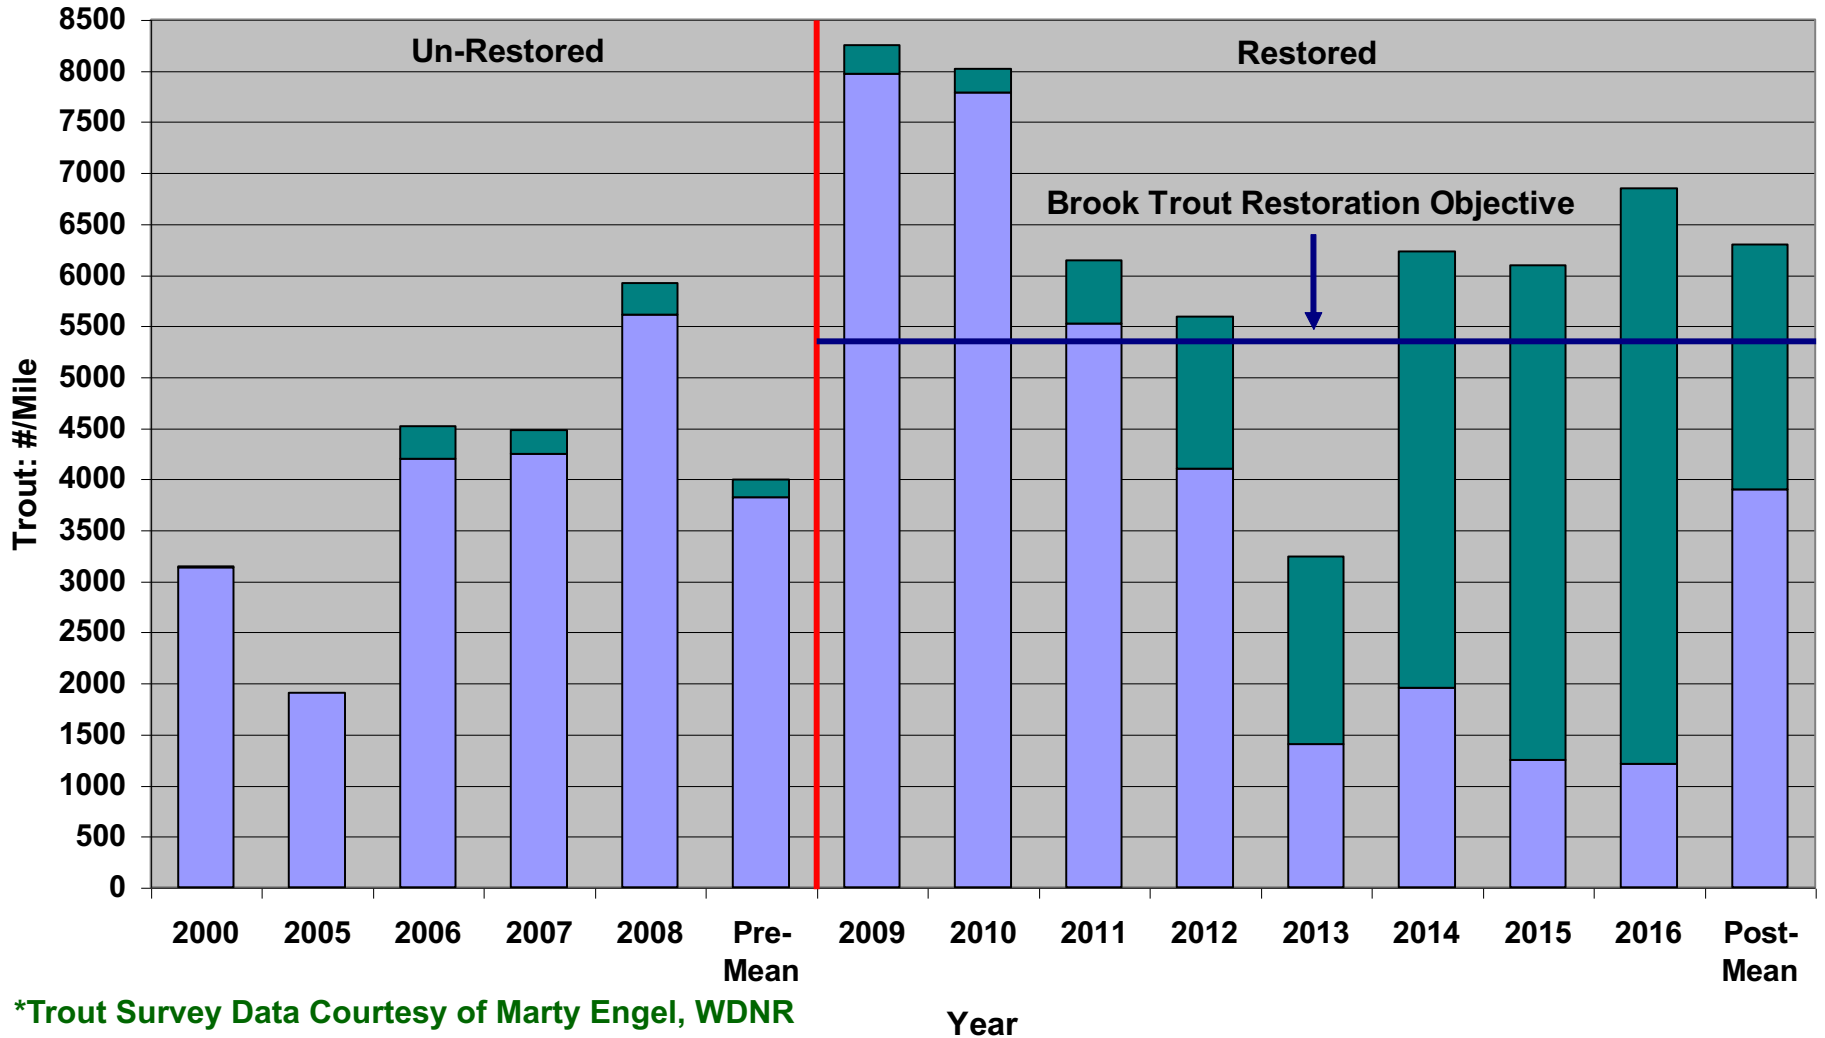
Pine Creek (2A) Pre- vs Post-Restoration Trout: Total/Mile

# Project Objective: Increase Numbers of Brook Trout by 40-50%

Brook Trout: Total/Mile      Brown Trout: Total/Mile

- Brown Trout were already present in low abundance (6%) pre-restoration, but Brook Trout dominated (94%)
- WDNR trout survey crews unsuccessfully attempted Brown Trout removal in 2007-2008, via electrofishing

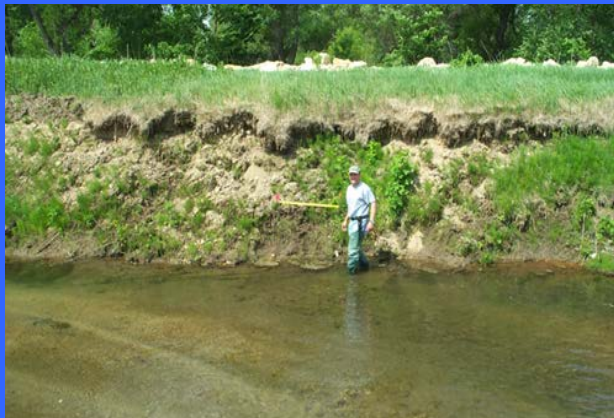
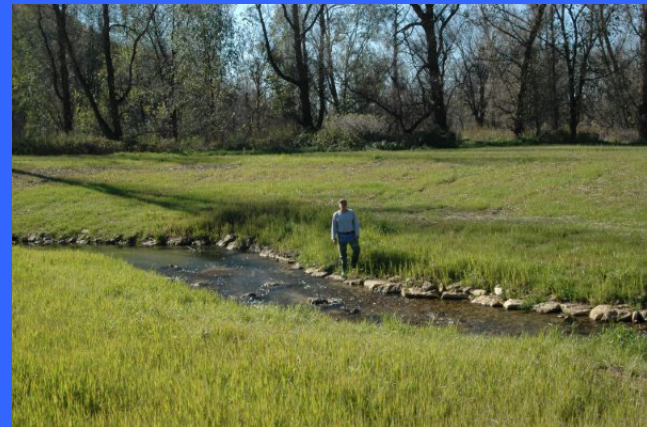
## Project Outcomes: Benefits

- Measurable improvement in the stream temperature regime, providing a buffer against future climate change impacts (Project Objective 1)
- 60% decrease in stream bank height, reducing erosion potential and re-connecting stream to floodplain (Project Objective 2)
- 140% increase in coarse stream bottom substrate (Project Objective 3)
- 133% increase in aquatic macrophyte presence (Project Objective 4)
- 40% decrease in stream channel width
- 75% increase in water depth
